# **Common Area Tree Assessment**

## **Woodland Hills Homeowners Association**

*Zimar & Associates, Inc.  
PO Box 855  
Manassas, VA 20113  
(703) 331-3731*

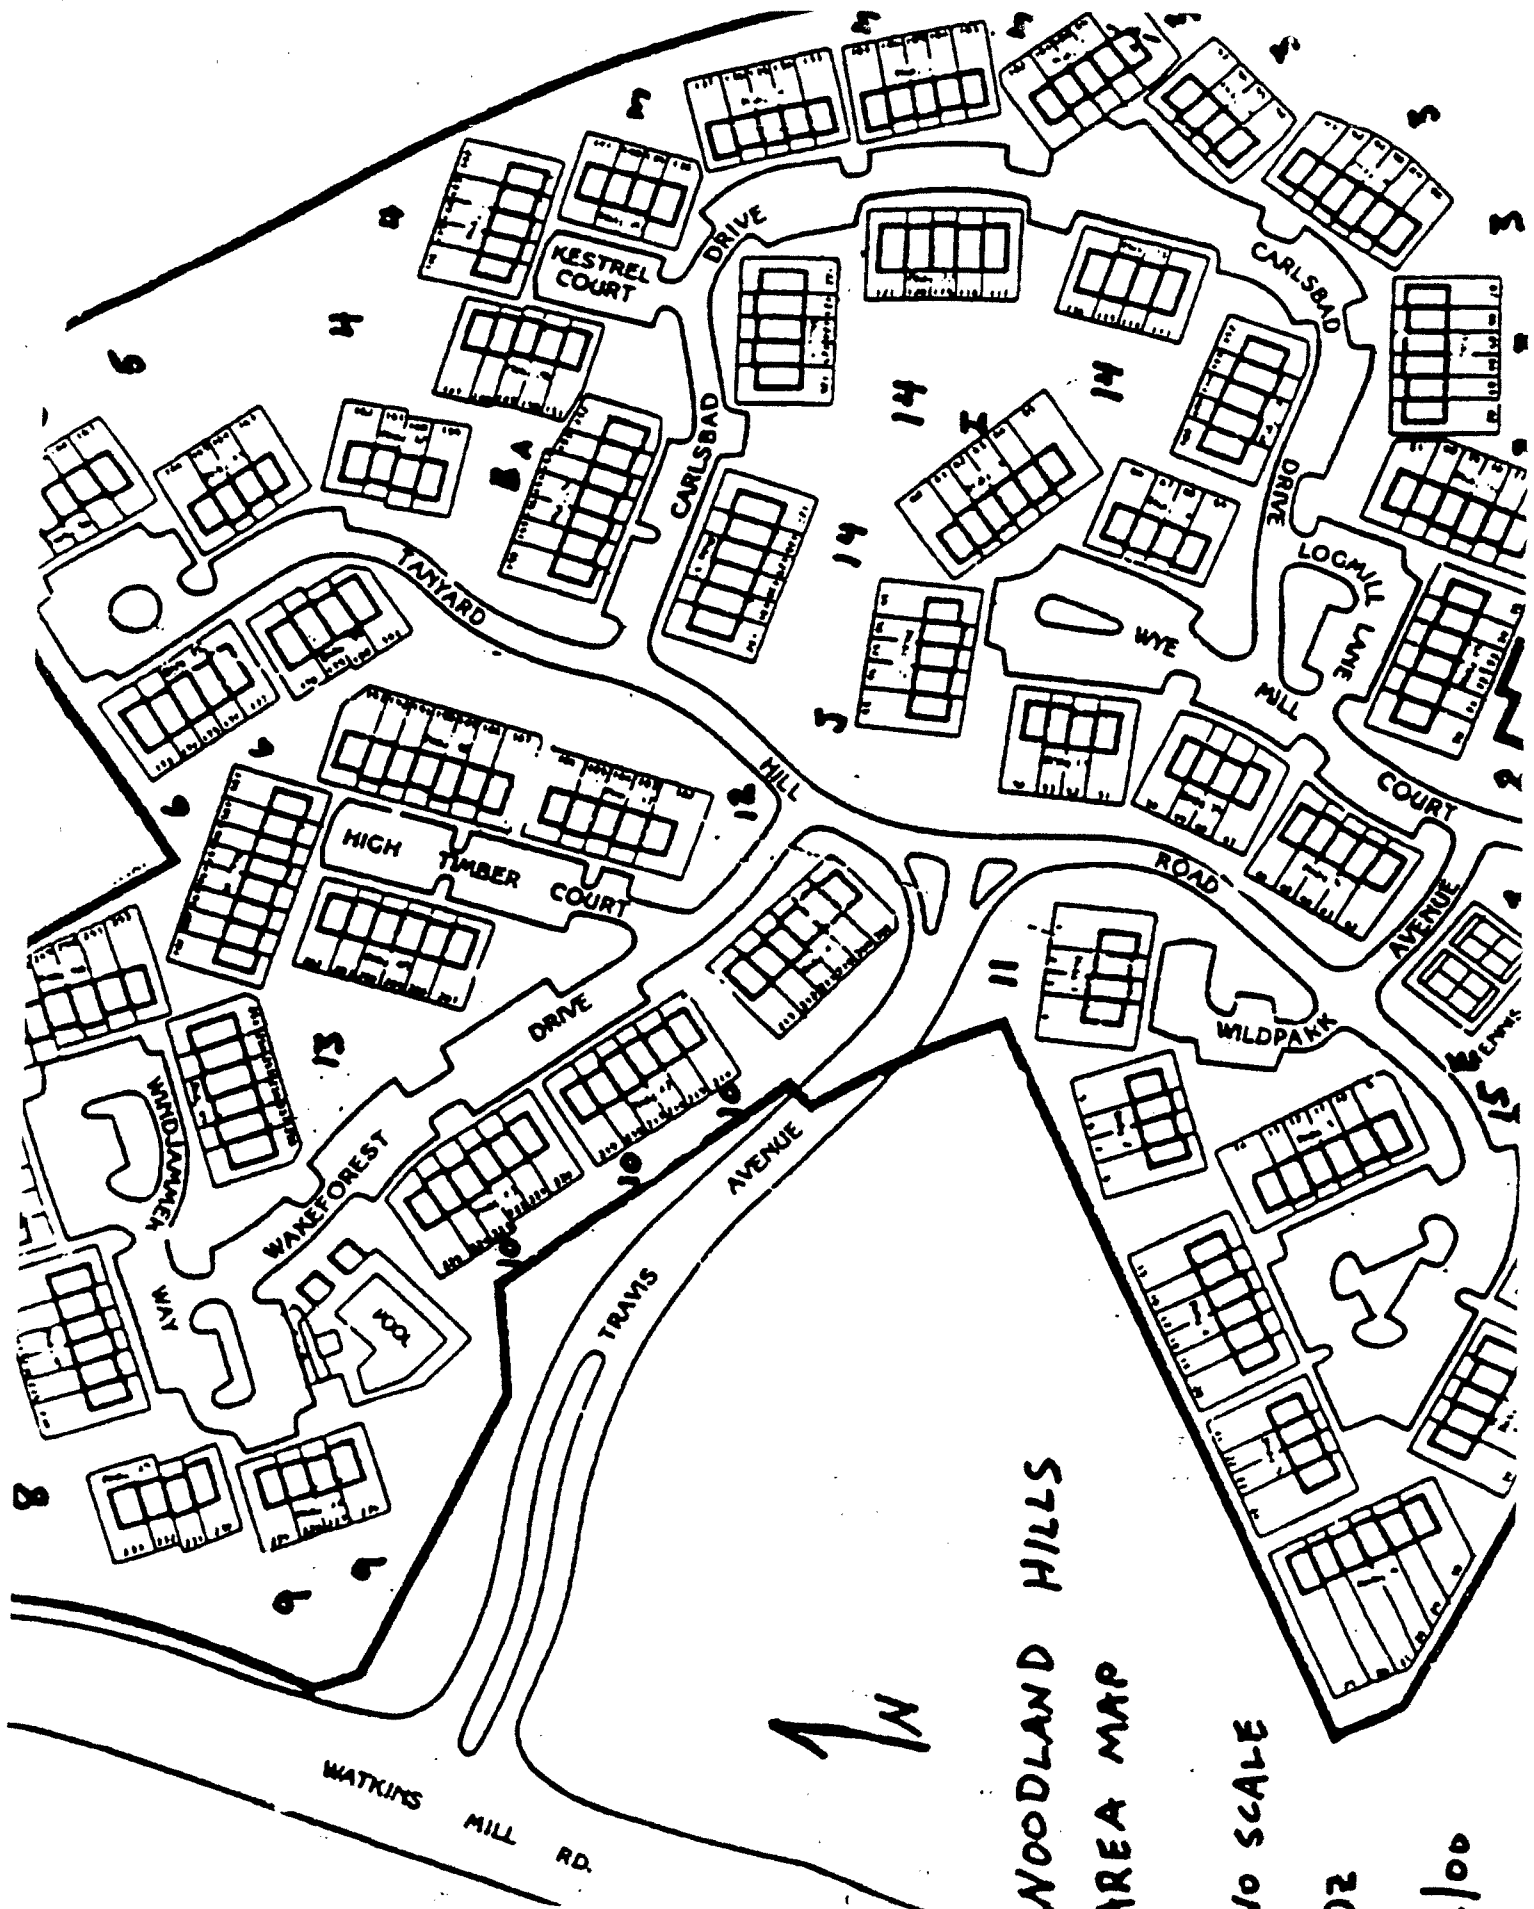
WOODLAND HILLS  
AREA MAP

There are two trees with large deadwood that require pruning to improve safety. Tree A is a twenty-four inch red oak with large deadwood. Tree B is a twenty-four inch red oak with large deadwood and a weak crotch. They should both be hazard pruned to improve safety. Tree B should also be cabled as indicated in the specifications in Appendix B in order to reinforce the structural weakness.

This area is comprised primarily of red oak, white oak, and hickory. Trees are generally in good condition. Sizes range from twelve to eighteen inches in diameter. The area is well used causing some compaction and minor sheet erosion. The edges bordering the parking area along Wakeforest Drive are being invaded by ailanthus. This invasion creates a rather unnatural and unkempt appearance and harsh edge along the parking area. White pine screening also exists in some places along the edges. Two trees, an eighteen inch red oak and a double twelve inch lead red oak labeled C and D respectively on the map in Appendix A have large deadwood and broken limbs hanging in them.

This is a large area of preserved oaks, hickories and red maples ranging in size from twelve to twenty four inches in diameter. The trees are generally in good condition. Parts of this area are heavily used leading to compaction and minor sheet erosion. Some areas of the understory have been thinned and cleared. Black cheery and red maple are growing as volunteers along many of the edges. Two trees, a twenty-inch diameter black cherry and a twenty-four inch diameter red oak have large deadwood hanging over areas frequented by residents. These trees are labeled I and J respectively.

This area is comprised of several trees preserved during the original development consisting of tulip poplar, black locust and red maple. They are in fair to poor condition. Extensive activity has taken place within their root zones. They are very near the tot lot in a highly used area. There are three trees, a sixteen inch diameter black locust, a triple trunk tulip poplar, and a 12" dead oak labeled C, D, and E respectively on the map in Appendix A that represent safety concerns.

- Hazard prune trees labeled F, G, and H to remove deadwood 2.0 inches and larger at their point of attachment.
- Mulch, to the greatest extent possible all trees. Ideally, this entire area could be mulched and reconverted to a more typical forest understory. Alternatively, create mulch beds around tree clusters that extend at least ten feet from the trunks of all trees and consolidate in irregular patterns. These mulch areas could be planted with understory tree and shrub species from the replanting list in Appendix C. Mulching will also reduce the erosion now occurring in this area.

Natural leaf litter should be allowed to accumulate in the interior area to reduce the potential for erosion. Trees C and D should receive hazard reduction pruning to reduce the potential hazard to users of the area.

Trees I and J should be hazard pruned to remove deadwood and dangerous limbs two inches and greater in diameter at their point of attachment.

Safety is a primary concern in this area due to the proximity of the tot lot. Therefore removal of tree C and E is a high priority. Tree E should receive three cables to prevent the multiple trunks from splitting apart. Tree E should also be hazard pruned at the time of cabling.
